UNDERWATER BRIDGE INSPECTION REPORT

STRUCTURE NO. L4870

ROOT RIVER

MINNESOTA DEPARTMENT OF TRANSPORTATION
UNDERWATER BRIDGE INSPECTION

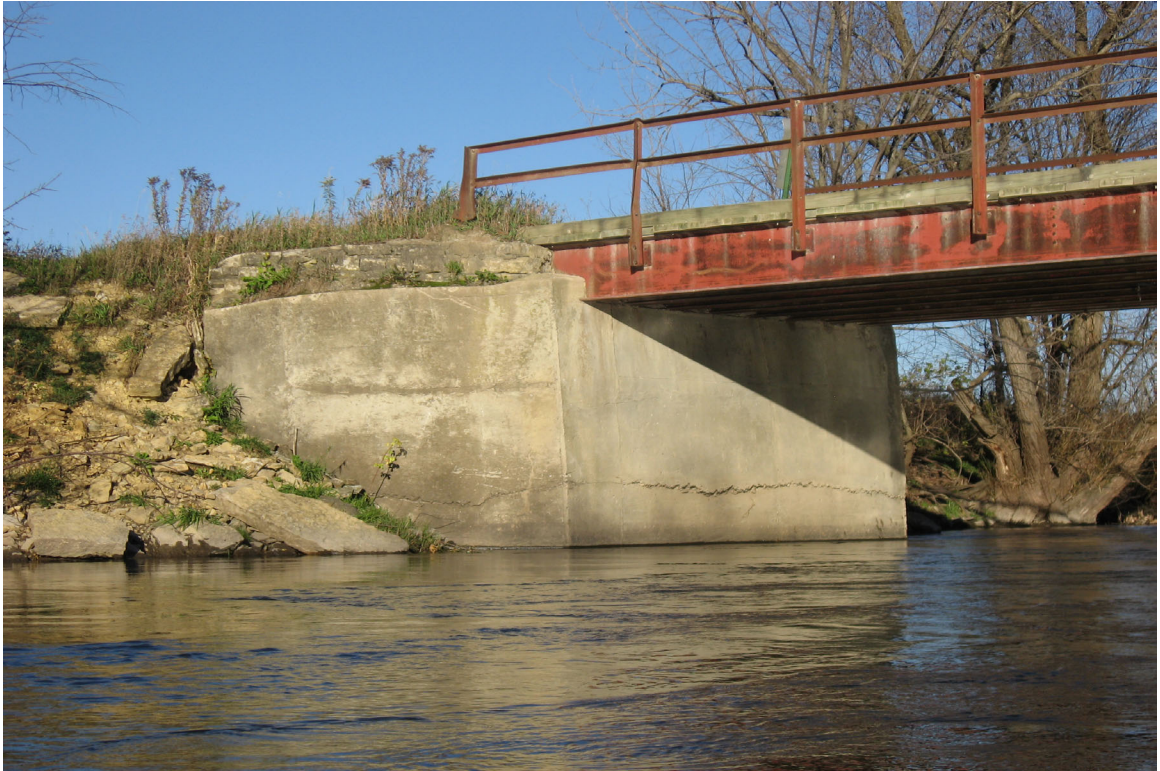
Photograph 1. View of North Abutment, Looking Northeast.

5. A concrete ledge was located at 1.7 feet below the waterline at the South Abutment and 1.8 feet below the waterline at the North Abutment.
6. Random areas of section loss were observed on the submerged portion of the North Abutment with average penetrations of 12 inches and no exposed reinforcing steel detected.

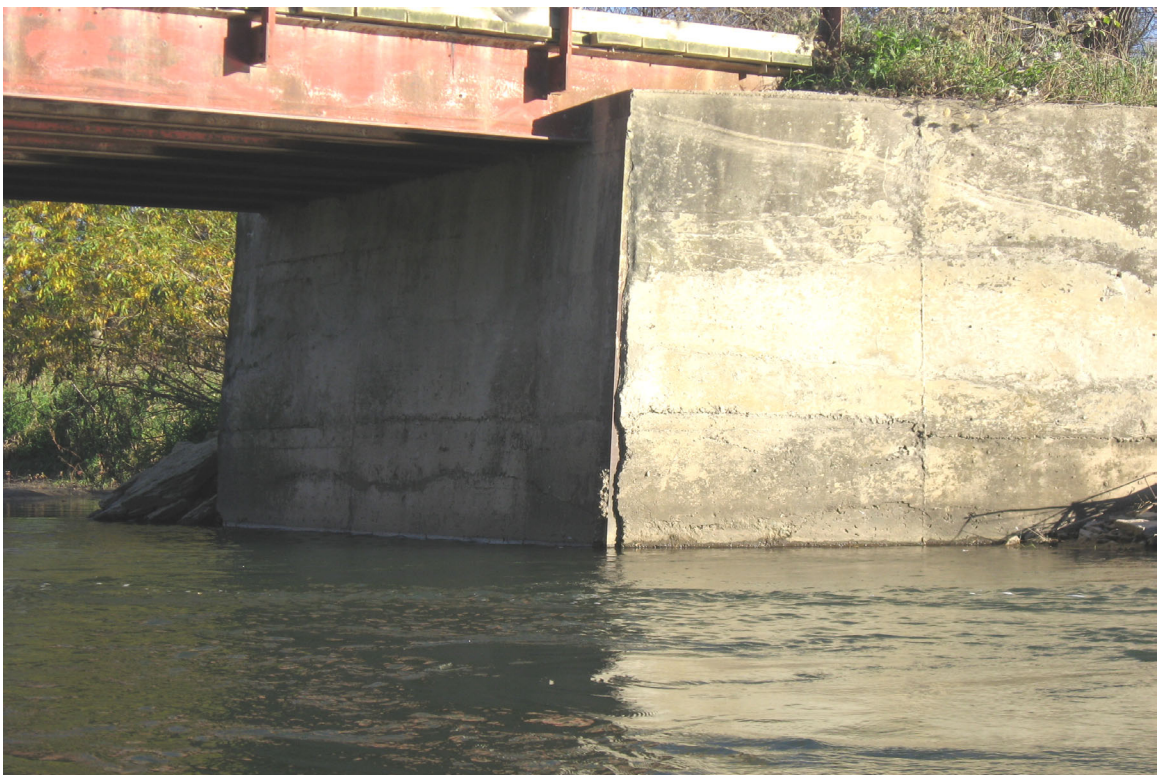
Photograph 2. View of South Abutment, Looking Southeast.

1. The channel bottom consisted of riprap with no probe rod penetration.
2. An area of poor consolidation was observed on the east corner of the South Abutment from 1.5 feet below to 1 foot above the waterline with 3 inches of maximum penetration.

3. A 6 inch band of poorly consolidated concrete was observed at the waterline extending from the downstream 1/4 point to the east wingwall.
4. The upstream half of the South Abutment concrete wall facing exhibited undermining that was 1.5 feet high with up to 1.5 feet of penetration, which exposed the underlying masonry. Random areas of section loss were observed on the submerged portion of the South Abutment facing with average penetrations of 6 inches which exposed heavily corroded vertical reinforcing steel at the center of the abutment.

7. A formed steel angle was exposed due to an area of section loss, up to 1 foot wide and 4 inches deep, on the west corner of the South Abutment which extended from 3 feet above to 2 feet below the waterline.

Monitor height of exposure and condition of the masonry wall exposed below the concrete facing at the South Abutment, and if deterioration continues, further concrete encasement may be required.
